Surgical Extrusion of A Complicated Crown-Root Fractured Tooth: Case Report

Türkiye Klinikleri J Dental Sci 2012;18(1):144-50

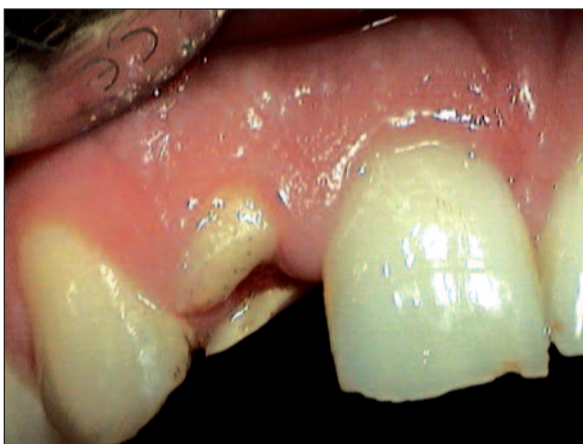
FIGURE 1A: Labial view of the tooth before surgical extrusion. (see for colored form <http://dishekimligi.turkiyeklinikleri.com/>)

A 32-year-old healthy man applied to the Ege University, Faculty of Dentistry, Department of Restorative Dentistry and Endodontics in February 2004 because of dental pain and esthetic care. He notified the clinician that he had fallen down the stairs two days ago. The patient's extraoral examination was normal however the intra-oral and radiographic examinations revealed a complicated crown-root fracture of the maxillary right lateral incisor. The fracture line extended to the marginal bone level, the coronal fragment was missing and the pulp was exposed to the oral cavity (Figure

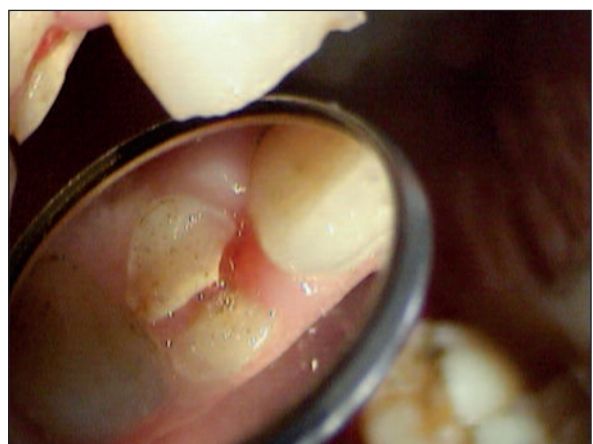
FIGURE 1B: Palatal view of the tooth before surgical extrusion. Note the proliferation of the gingival tissue between the coronal fragments. (see for colored form <http://dishekimligi.turkiyeklinikleri.com/>)

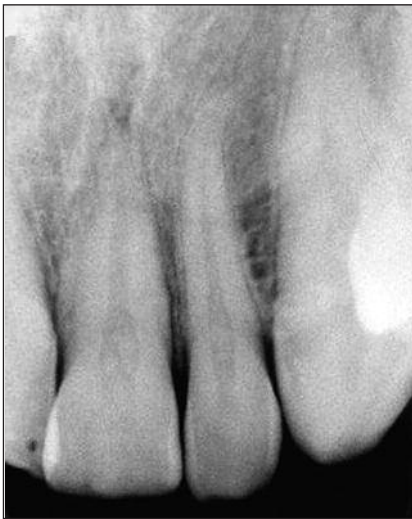
FIGURE 2B: The radiographic image of the other side after trauma.

1A, 1B). The electrical pulp test response was positive. The patient had both spontaneous and provocative pain. Radiographic examination did not reveal any horizontal root fractures (Figure 2A, 2B).

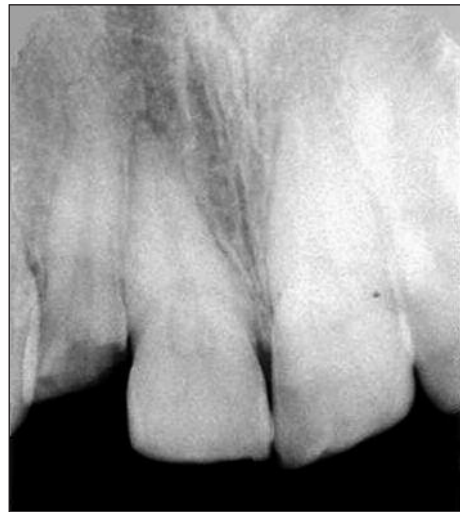
FIGURE 2A: The radiographic image of the tooth after trauma.

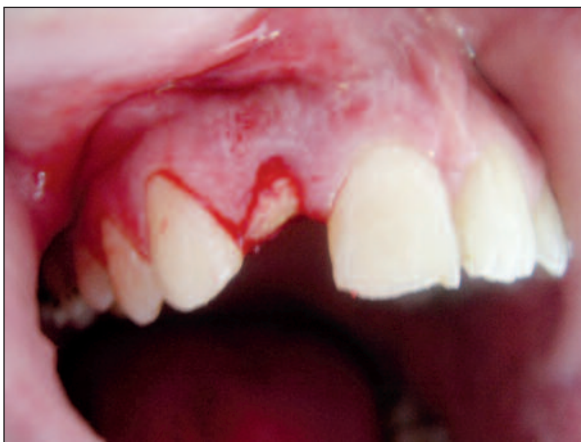
FIGURE 3A: Gingival tissues separated without causing trauma to the surrounding bone.
(see for colored form <http://dishekimligi.turkiyeklinikleri.com/>)

The patient referred to Ege University, Faculty of Dentistry, Department of Oral and Maxillofacial Surgery for surgical extrusion. He was administered local anesthesia (0.125 mg/mL epinephrine, 2 g/mL lidocaine). After anesthesia, gingival tissues were separated by a Bein elevator without causing trauma to the surrounding bone. The tooth was extruded till the fracture line was leveled by canine and controlled for hemostasis (Figure 3A, 3B, 3C).

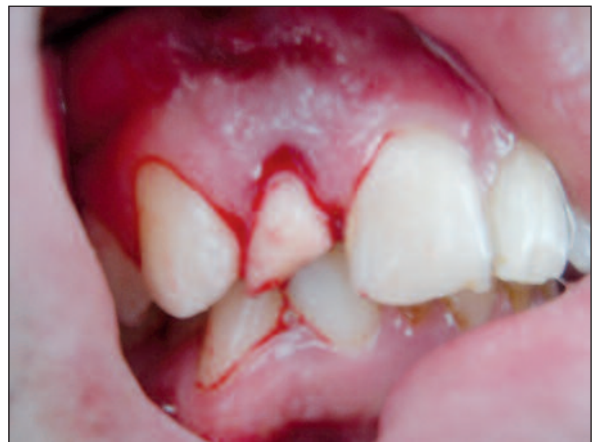
FIGURE 3B: The lateral incisor repositioned inferiorly till fracture line leveled by canine tooth.
(see for colored form <http://dishekimligi.turkiyeklinikleri.com/>)

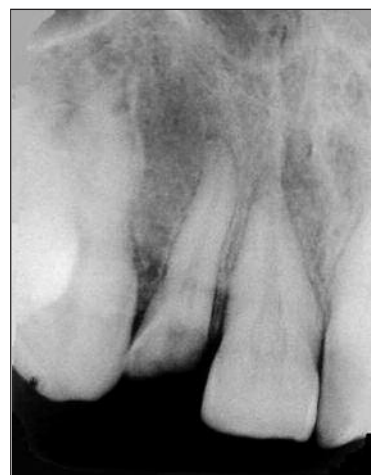
FIGURE 3C: The radiographic image of the tooth after surgical extrusion.

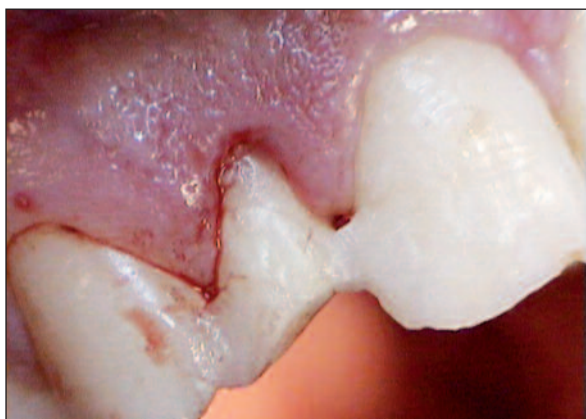
FIGURE 4: Labial view of the tooth after being splinted to adjacent teeth with composite resin.

After the surgical extrusion, tooth was splinted to the right central incisor and right canine with composite resin for two weeks (Figure 4). Antibiotic therapy was prescribed for 10 days and the patient was motivated to maintain oral hygiene.

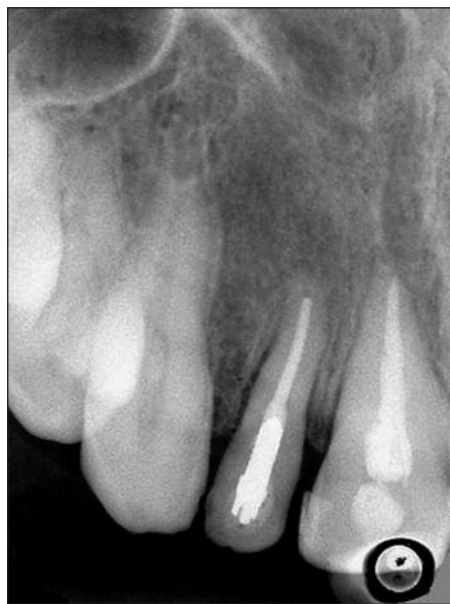
FIGURE 5: The radiographic image of the tooth after the root canal treatment and the placement of the metal post.

Before the fabrication of the porcelain fused-to-metal crown, a metal post was placed into the root canal and a composite core was built up (Figure 5). Then, porcelain fused-to-metal crown was fabricated with conventional technique (Figure 6A, 6B).

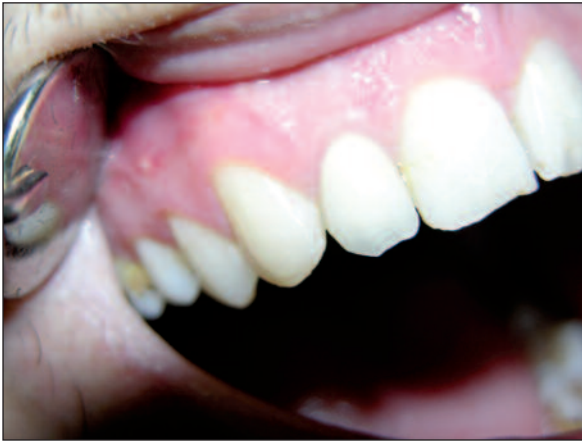
FIGURE 6A: Labial view of the tooth after porcelain fused-to-metal crown was fabricated.

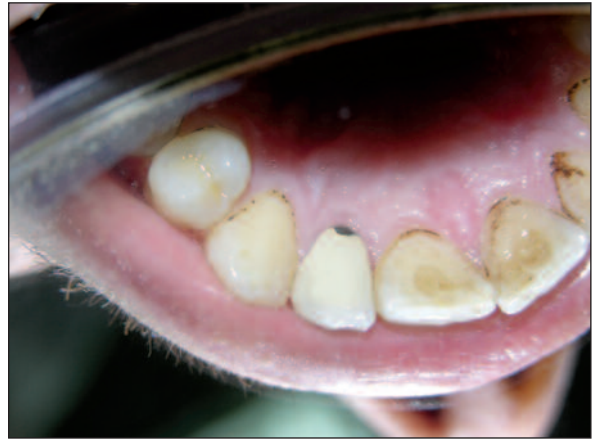
FIGURE 6B: Palatinal view of the tooth after porcelain fused-to-metal crown was fabricated.

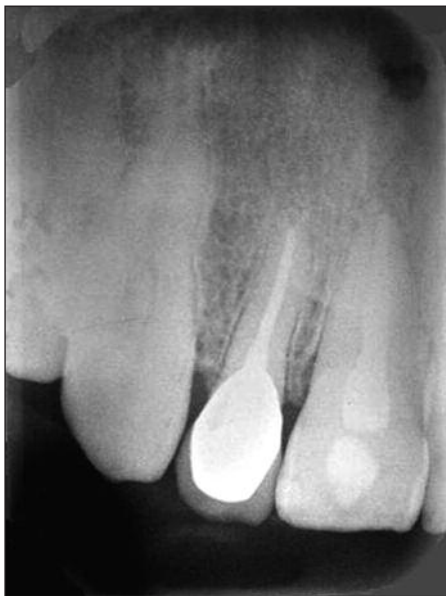
FIGURE 7A: The radiographic image of the tooth after one year.

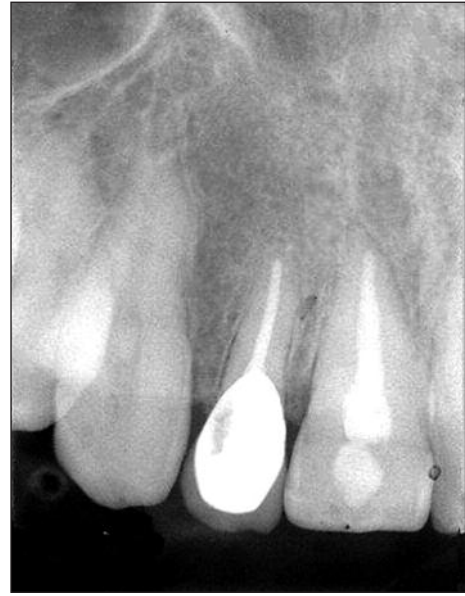
FIGURE 7B: The radiographic image of the tooth after three years.

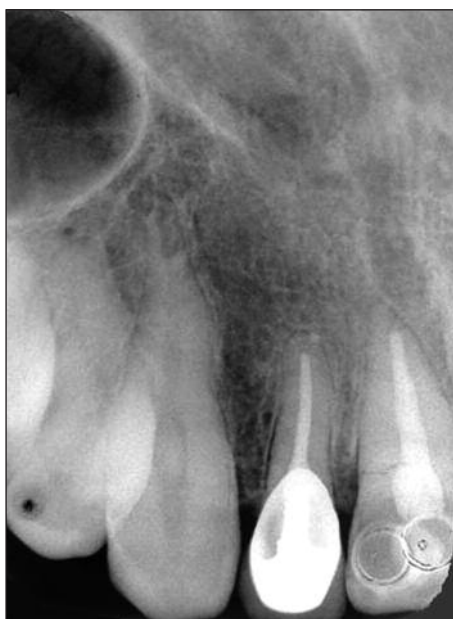
there was no marginal bone loss, either (Figure 8A, 8B, 8C). The tooth and the restoration were functionally and aesthetically acceptable.

FIGURE 8A: A five-years follow-up radiograph showing no root resorption and marginal bone loss.

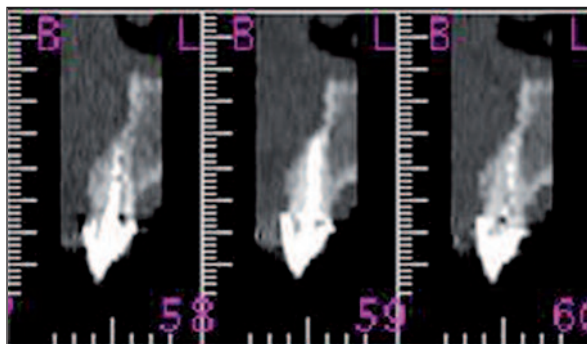
FIGURE 8B: The view of the maxilla obtained from computerized tomography after five years (Siemens Somatom Plus4, Dental CT Programme). (see for colored form <http://dishekimligi.turkiyeklinikleri.com/>)

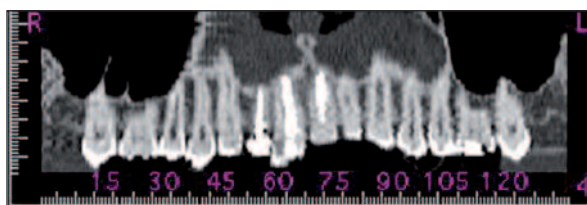
FIGURE 8C: The image obtained from CT was spirally scanned with 1 mm of cross-section after five years. (see for colored form <http://dishekimligi.turkiyeklinikleri.com/>)

When alveolar bone is subjected to a surgical procedure, a loss of osseous crest may be expected during healing.¹⁶ The loss of marginal bone was examined with radiographic controls during the follow-up period. It is known that dental periapical radiography supplies only two dimensional image, and it is insufficient to examine the changes of alveolar bone. However, computerize tomography is a developed technique which supplies three dimensional image. Therefore, in this study, computerize tomography (Siemens Somatom Plus 4, Dental CT Programme) was used together with dental periapical radiography for the last radiographic control to examine root resorption and/or alveolar bone loss (Figure 8B). Then the image obtained from CT was spirally scanned with 1 mm of cross-section (Figure 8C) and the examination revealed that there was no loss of marginal bone or root resorption.
