Malposition of Transvenous Pacemaker Lead in Left Ventricle-An Incidental Finding: Case Report

Türkiye Klinikleri J Cardiovasc Sci 2010;22(1):138-9

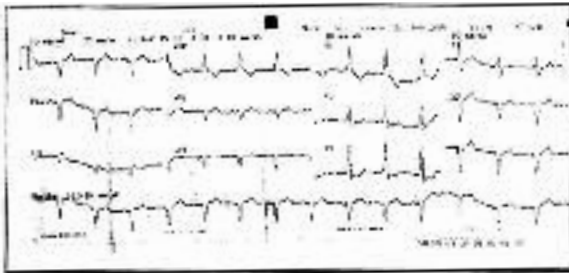
FIGURE 1: The electrocardiogram showing right bundle branch block pattern rather than typical left bundle branch block.

amination. His electrocardiogram showed complete right bundle branch block configuration instead of typical left bundle branch block pattern in the paced mode suggesting a pacemaker lead in left ventricle (Figure 1). Subsequently we performed an echocardiography which is confirmed that pacing lead had passed through the foramen ovale into the left ventricle (Figure 2). The patient was asymptomatic and received no anticoagulant therapy. There is limited experience regarding management of this complication, transcatheter or surgical lead extraction was not considered in this patient because of his age and to avoid the risk of embolization anticoagulant therapy was initiated.

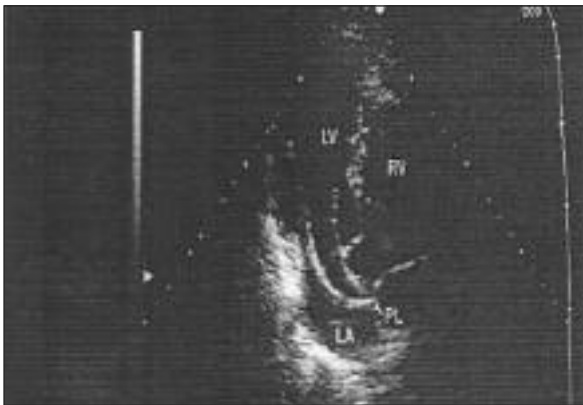
FIGURE 2: The echocardiography showing pacemaker lead (PL) passing through patent foramen ovale to the left atrium (LA) and left ventricle (LV); RV: Right ventricle.
